Risk and Health & Safety Working Party
Tuesday 16 April 2019 at 8.30am

TITLE:	Seismic Assessment of Water Street Offices
ID:	
From:	Phil Heatley, Strategic Projects Manager

SEISMIC ASSESSMENT

Northland Regional Council Buildings
36 Water Street, Whangarei
(Lot 2 DP 65220, Pt Allot. 1 Parish DP 5077)

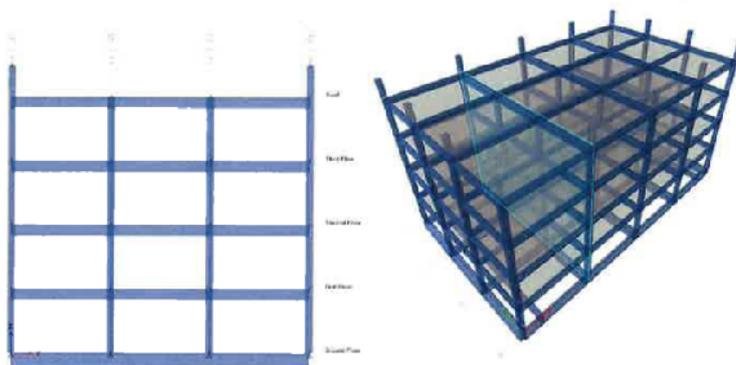
Four Storey Building: Grid 2-4

Pounding could occur with more than 0.75% drift. Measured column stirrup spacing as far as 420mm. Panel drift limit is 0.79% (15mm/1900mm).

Result: Target Drift 0.75%: T = 1.7s, 40%NBS (IL2), site subsoil D, Z=0.13

Target Drift 0.75%: T = 1.7s, 52%NBS (IL2), site subsoil D, Z=0.10

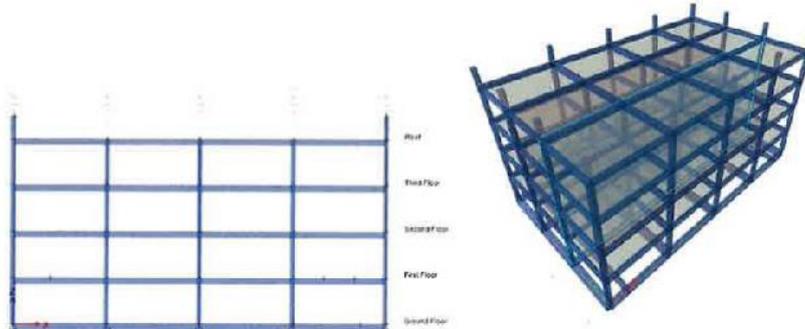
Four Storey Building: Grid B-C

Pounding could occur with more than 0.75% drift. Measured column stirrup spacing as far as 420mm. Panel drift limit is 0.79% (15mm/1900mm).

Result: Target Drift 0.75%: $T = 2.4s$, 32%NBS (IL2), site subsoil D, $Z=0.13$
Target Drift 0.75%: $T = 2.4s$, 41%NBS (IL2), site subsoil D, $Z=0.10$

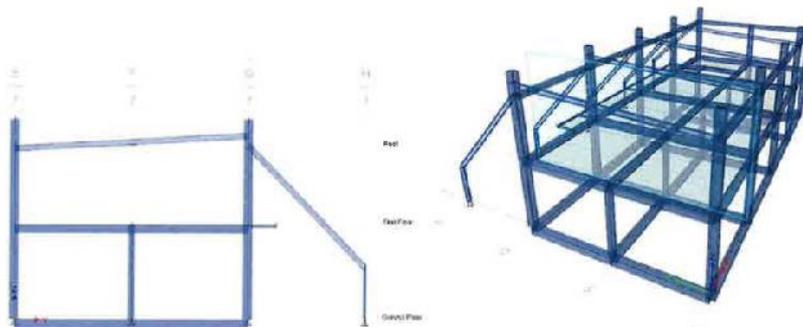
Two Storey Building: Grid 7-9

Pounding could occur with more than 0.75% drift.
Panel limit is 0.60% drift (15mm/2500mm panel)

Result: Target Drift 0.60%: $T = 0.6s$, 46%NBS (IL2), site subsoil D, $Z=0.13$
Target Drift 0.60%: $T = 0.6s$, 60%NBS (IL2), site subsoil D, $Z=0.10$

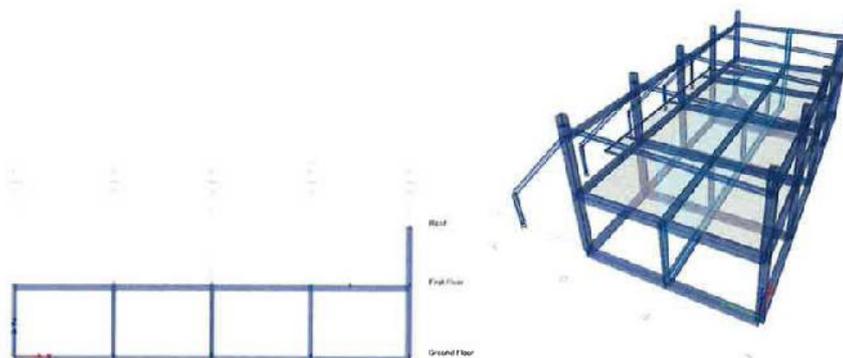
Two Storey Building: Grid F

Pounding could occur with more than 0.75% drift.
Panel limit is 0.60% drift (15mm/2500mm panel)

Result: Target Drift 0.60%: T = 0.6s, 46%NBS (IL2), site subsoil D, Z=0.13
Target Drift 0.60%: T = 0.6s, 60%NBS (IL2), site subsoil D, Z=0.10
